# Preventative approach to road maintenance in France

# Chip Sealing road maintenance in France revealing facts

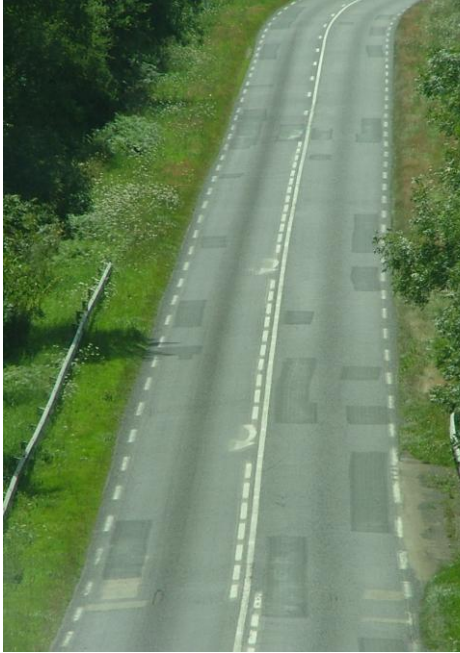
AC pavement exhibiting Chip Seal surface dressing maintenance throughout life up until total resurface dressing takes place.

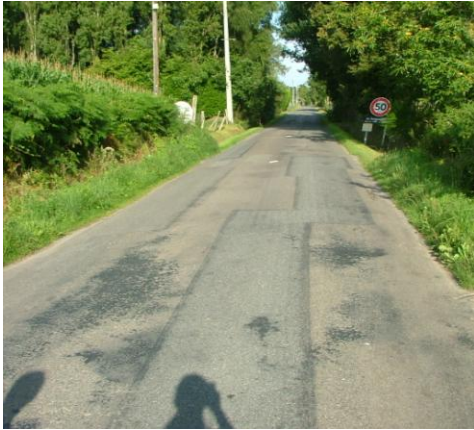
A typical French village road with surfacing maintenance applied when and where needed.

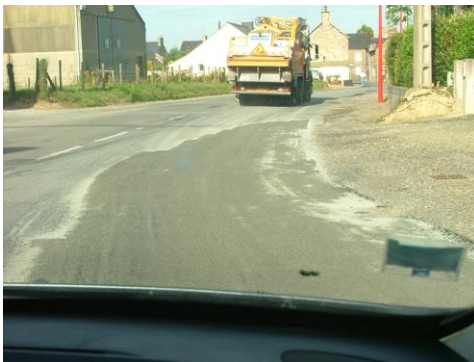
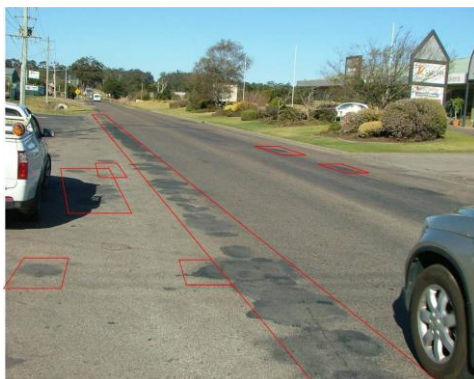
Example of a road surface in Australia that would benefit from surface dressing patches.
